**REGULAR MEETING AGENDA
PAJARO DUNES GEOLOGIC HAZARD ABATEMENT DISTRICT
VIRTUAL MEETING via ZOOM**

5. ITEM-Review the 2022 Seawall Inspection Report

This report presents the results of observations from our annual inspection of the rock revetment (seawall) and river wall at the subject property. The inspection services presented in this report were undertaken at the request of the Pajaro Dunes Geologic Hazards Abatement District (PDGHAD). This report presents a summary of our Second inspection report of the rock revetment and river wall. Our first inspection results are presented in our previous inspection memo, dated September 6, 2019. In addition, three previous inspections were performed by Arup. The results of Arup's previous annual inspections are presented in their reports, dated January 9, 2012; April 29, 2013; and November 7, 2014.

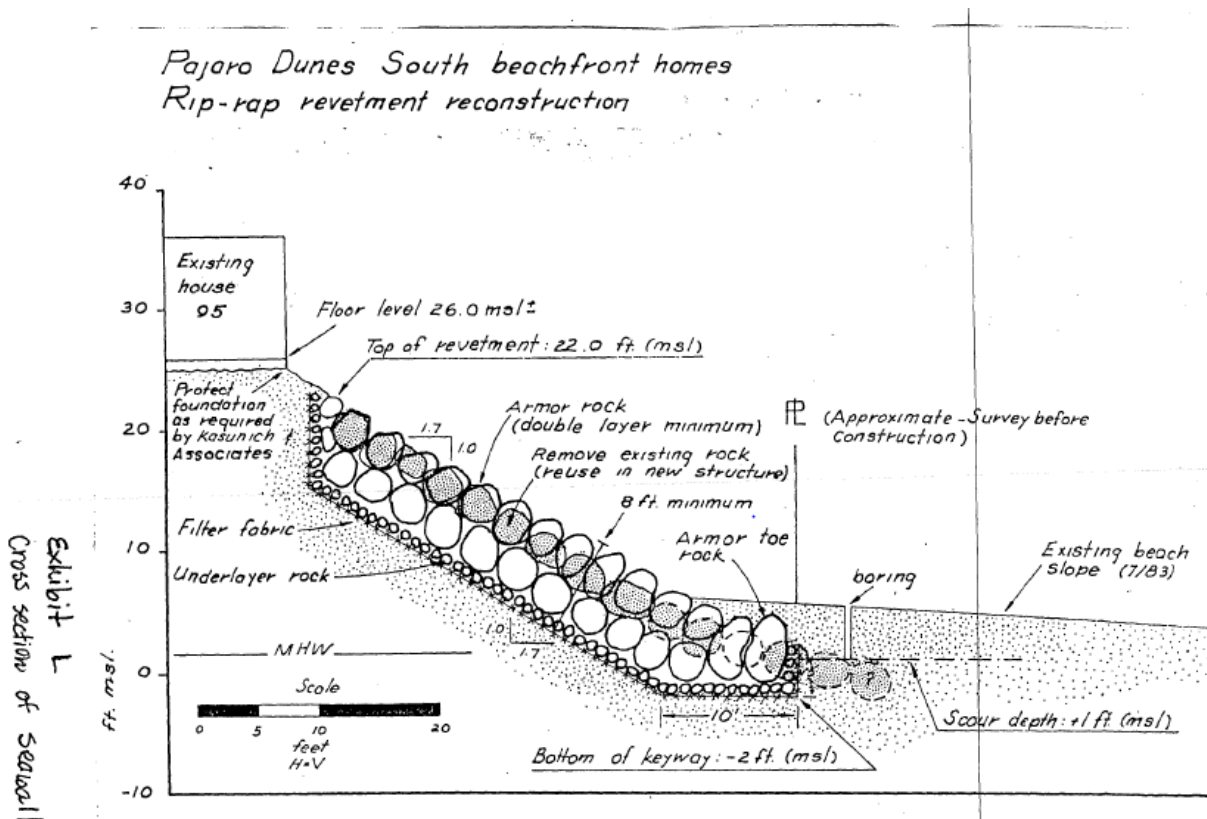
Inset Figure -01 Final Sea Wall Permit Schematic (SCC,1986)

- Base of keyway width = 10 feet (SCC, 1986)
- Rip-rap thickness = min 8 feet (SCC, 1986)
- Filter fabric at base of revetment = either plastic filter cloth or 700X “Mirafi.” (“Revetment Specifications” - SCC, 1986)

- Revetment = armor rock (double layer minimum) (SCC, 1986)
